Wood is not what it used to be!

Kevin M. Kelly, Jay-K Independent Lumber Corp, New Hartford NY 13413

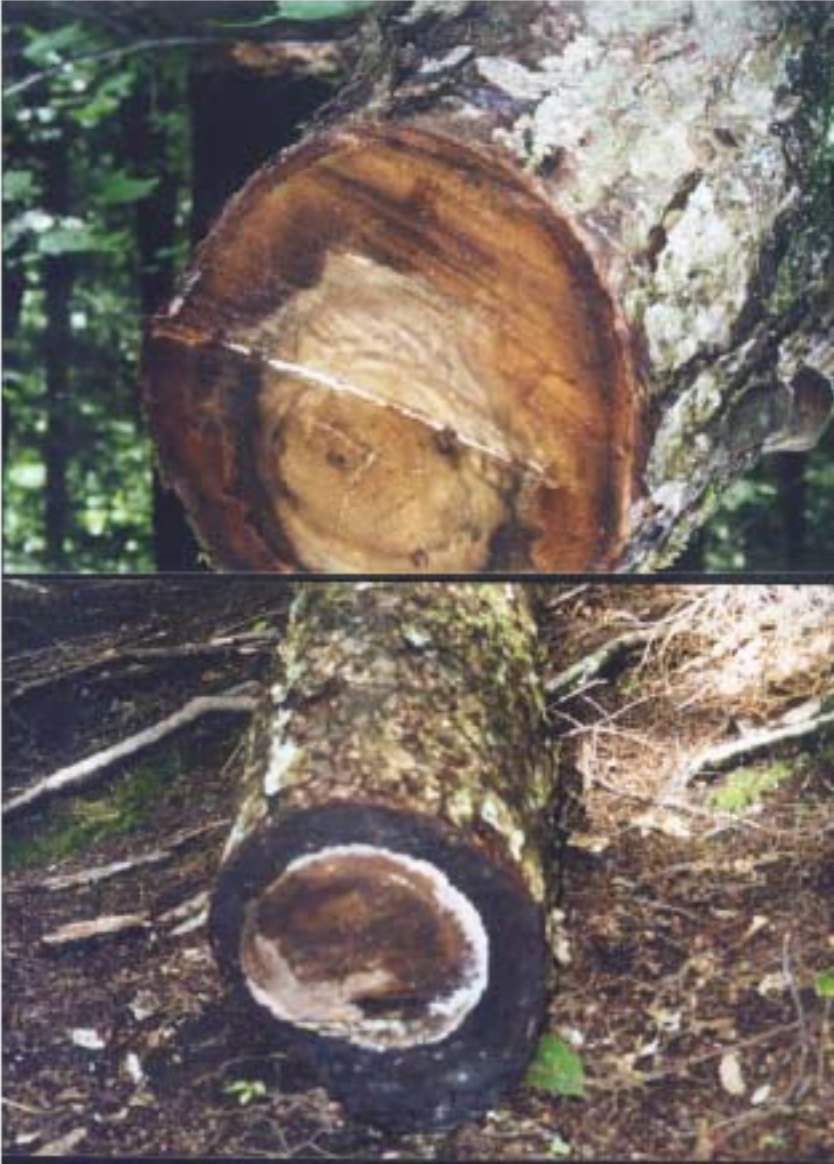
The following pictures illustrate bark, sapwood, heartwood, and bacterial action in logs in a forest setting.

The tree in the top picture has more sapwood because it was a faster growing tree or grew in an open forest. The tree in the lower picture grew in a densely forested section of the Adirondack Mountains. This may explain it's having so little sapwood. The species of tree may also make a difference. "The differences in color are related to the differences in moisture content and nutrient levels between the heartwood and sapwood. In the upper picture, the sapwood appears to be darkened by either bacterial action and/or enzymatic staining which occurs when the sapwood sugars are exposed to oxygen [9]."

"In the lower picture, the sapwood is heavily infested with mold fungi that thrive on rich nutrient sources with high moisture content. The white mycelium forming at the heart/sap boundary is probably from a decay fungus [9]."
